U.S. Air Force Airfield Damage Repair (ADR) Modernization Program

Large Crater Repair at Silver Flag Exercise Site, Tyndall Air Force Base, Florida

August 2015

Final report

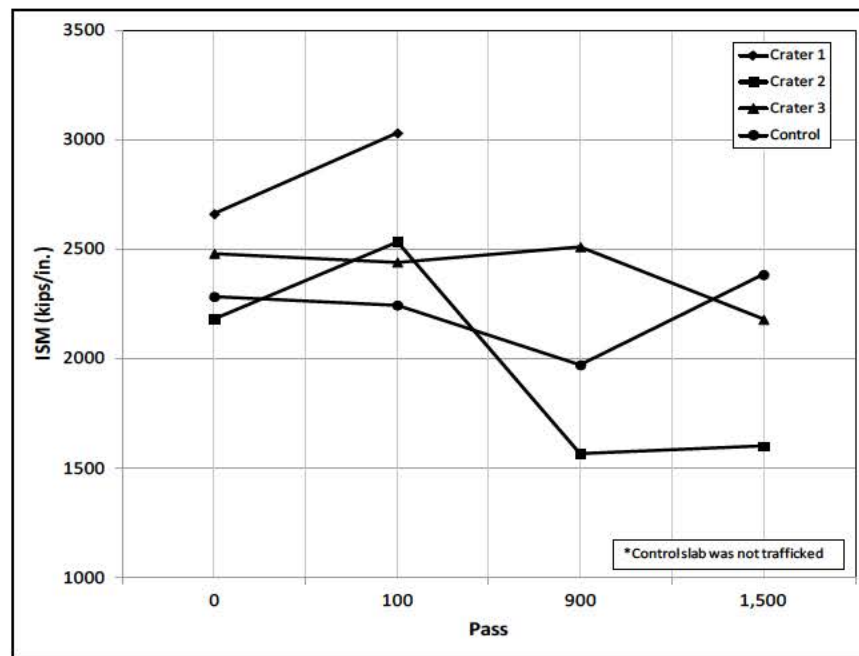
Figure 53. HWD data of large crater repairs.

The ISM data from the HWD is plotted for each crater at each pass level in Figure 53. The ISMs before trafficking are considerably lower than those reported by Edwards et al. (2013) and Bell et al. (2013). Typically the ISMs for the rapid-setting concrete are between 3,500 and 4,500 kips/in. However, the measured ISMs collected at the 0 pass level ranged between 2,181 and 2,661 kips/in. The HWD data contradicts the compressive strength data discussed in Section 5.4.4, which showed that each quadrant of each crater repair exceeded the required 28-day compressive strength. For Crater 1, data was collected only at 0 and 100 passes, and the ISM increased slightly between those two intervals. Crater 2 showed a slight increase between 0 and 100 passes and then a considerable drop at 900 and 1,500 passes, as the crater repair began to fail under traffic. The ISM for Crater 3 generally remained the same until dropping moderately at 1,500 passes. The control test point showed that the PCC slab stiffness generally remained consistent. Overall, the stiffness of the repairs was generally as high or higher than the control slab, until accumulating damage from traffic.

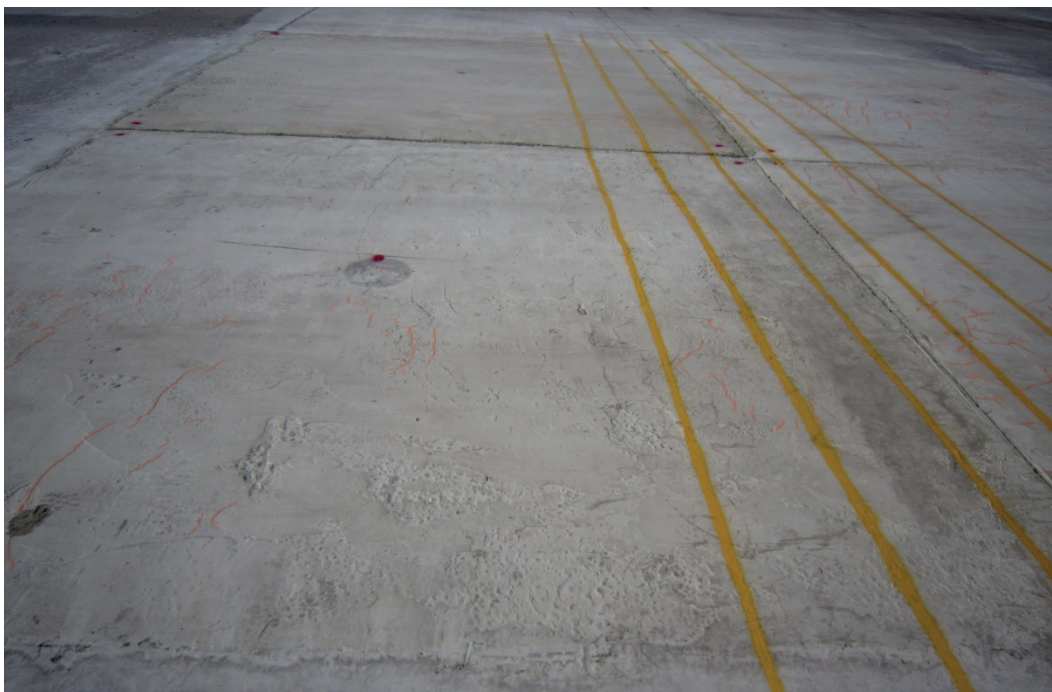
Figure 56. Crater 2, west quadrants, finished repair.

Figure 56 shows the west quadrants of Crater 2 after repair. Some shrinkage cracks (highlighted in orange) and small surface defects were noted. Figure 57 shows the east quadrants of Crater 2. Both quadrants exhibited shrinkage cracking, and the northeast quadrant contained considerably more than the southeast quadrant. Overall, the finish of Crater 2 was much smoother than Crater 1.

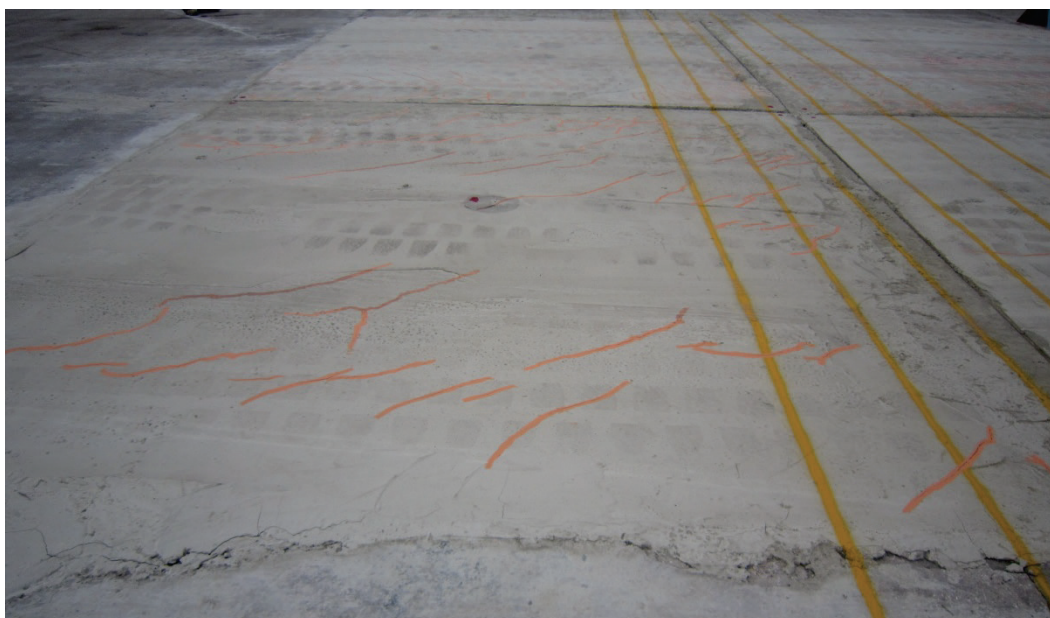
Figure 58. Crater 3, west quadrants, finished repair.

Figure 58 displays the west quadrants of Crater 3, and Figure 59 shows the east quadrants. Both western quadrants contained a considerable amount of shrinkage cracking. Also, the south edge of the southwest quadrant was not square due to damage sustained to that edge during excavation. The eastern quadrants both contained a substantial amount of shrinkage cracking. Figure 60 shows the large amount of shrinkage cracks in the northeastern quadrant.

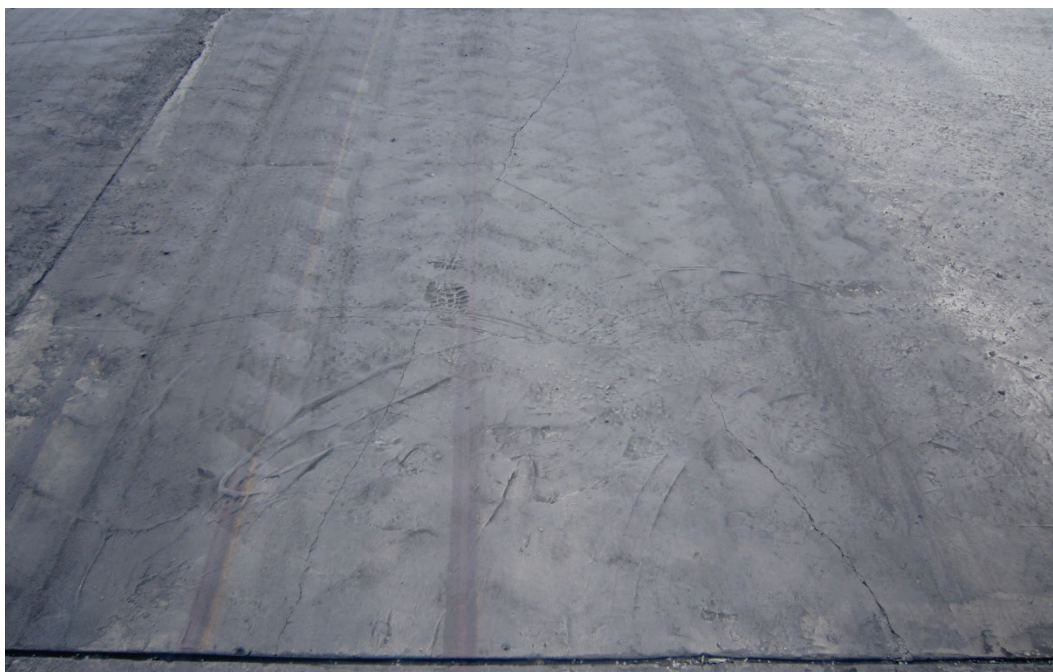
Figure 63. Crater 1, 400 passes, shattered slab in southwest quadrant.

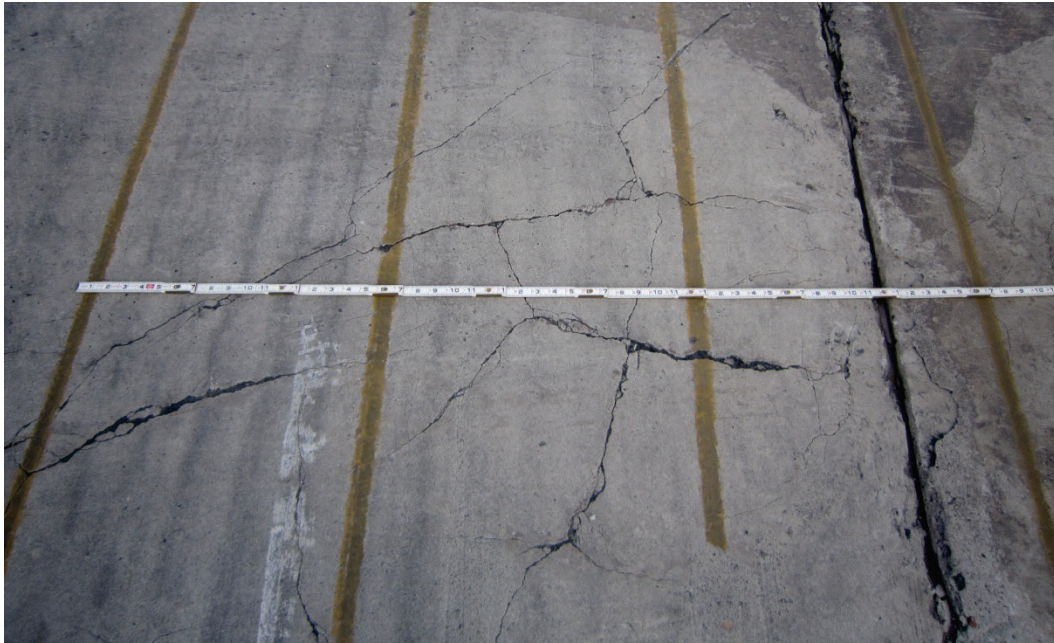
After 100 passes were applied to Crater 2, no new distresses were observed. At 200 passes, small, low-severity longitudinal cracking ($< 1/8$ in. wide) was apparent, and these cracks grew to medium-severity ($1/8$ in. to 1 in. wide) after 400 passes. At 900 passes, more of the medium-severity cracks began to connect, particularly on the southeast quadrant near the intersection of the four quadrants as shown in Figure 64. In addition, some delamination of a $1/2$ -in. layer in the traffic lane produced FOD potential as shown in Figure 65.

Figure 64. Crater 2, 900 passes, medium-severity cracking.

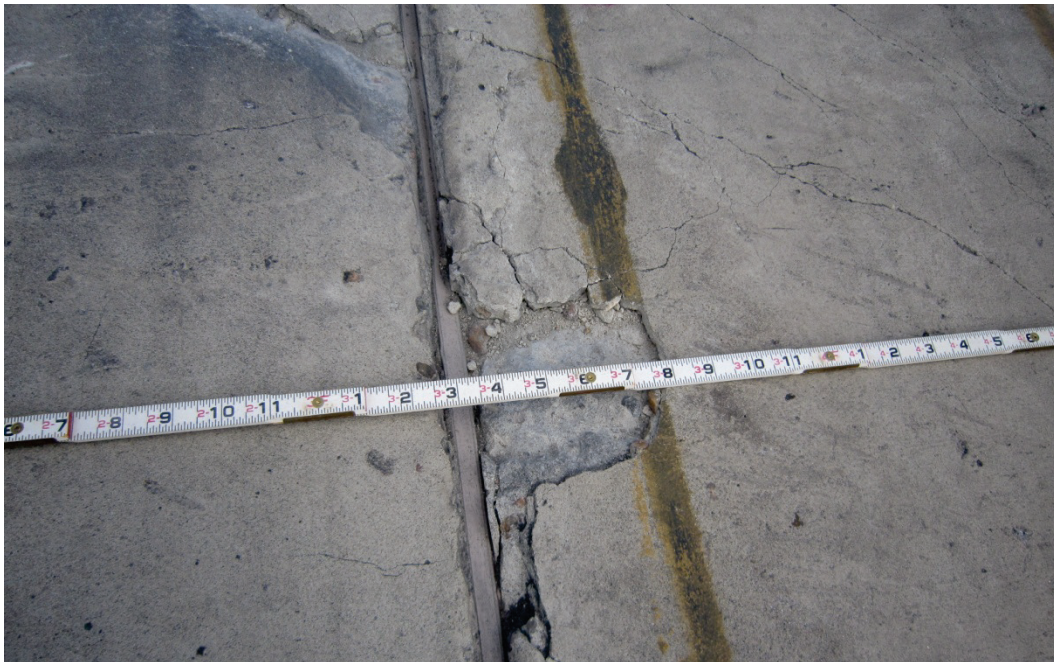
Figure 65. Crater 2, 900 passes, high-severity joint spall.

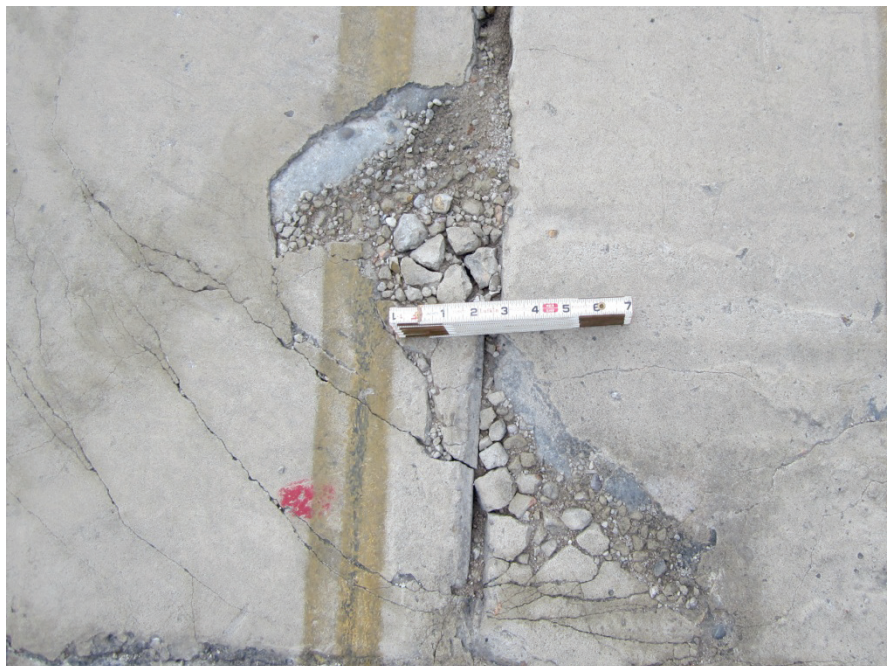
Figure 67. Crater 2, 1,500 passes, high-severity joint spall.

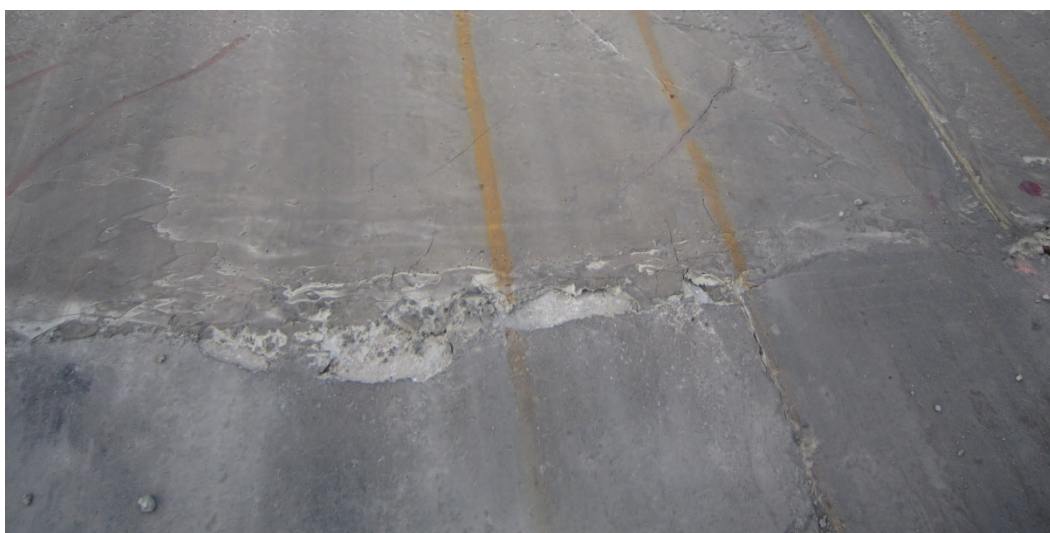
For Crater 3, the only new distress observed at 100 passes was some spalling along the joint that was perpendicular to traffic in the southwest quadrant as shown in Figure 68. The spalling was likely caused by a small amount of concrete that was placed to fill the void created during excavation, as discussed in Section 5.4.6. After 900 passes, a low-severity corner break and low-severity longitudinal cracking were noted. The spall shown in Figure 68 continued to produce FOD, but the joint was kept clean during trafficking. Trafficking continued, since this was not considered a structural failure and could be sustained by normal sweeping of the runway surface.

Figure 68. Crater 3, 100 passes, medium-severity joint spall.

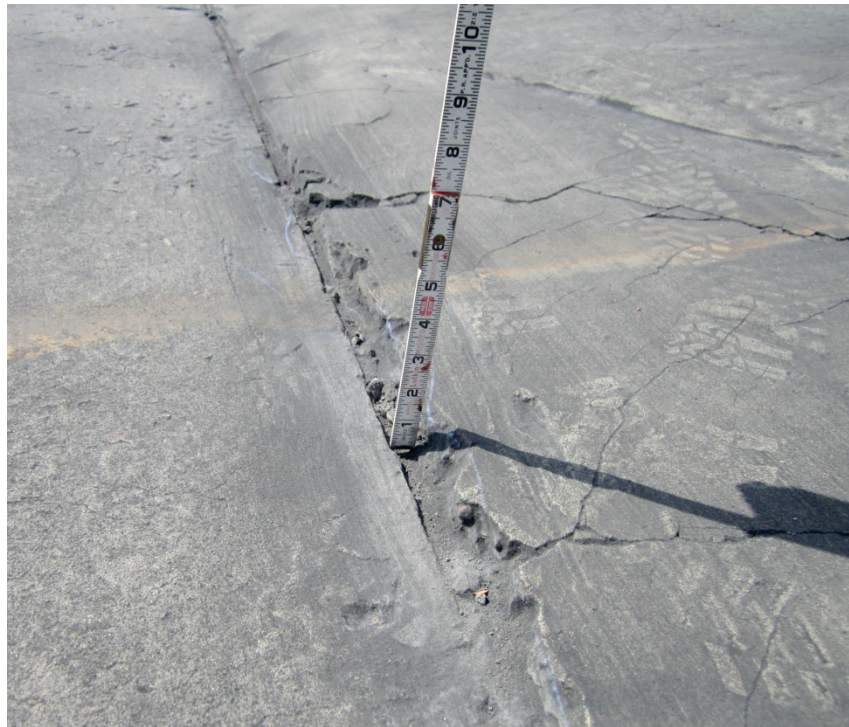
After 1,500 passes, several distresses were observed. Two medium-severity corner breaks were noted near the point where the four quadrants intersect. The joint spall previously mentioned continued to produce a large amount of FOD, and a deep joint spall was observed in the northwest quadrant as shown in Figure 69. Due to signs of structural failure and possible tire hazards, Crater 3 was considered failed at 1,500 passes and trafficking ceased.

Figure 69. Crater 3, 1,500 passes, high-severity joint spall.
